**Flood Control Project Maintenance
Levee Inspections**

Maintenance Issue Types Only, Levee Inspection Report By Mile - Spring 2017

Reclamation District No. 1600 Mull

Waterway	Bank	Unit Miles	Inspection Start/End	Inspector
Unit No. 01 Sacramento River	Right	10.46	04/11/2017 04/11/2017	Zach Jojola

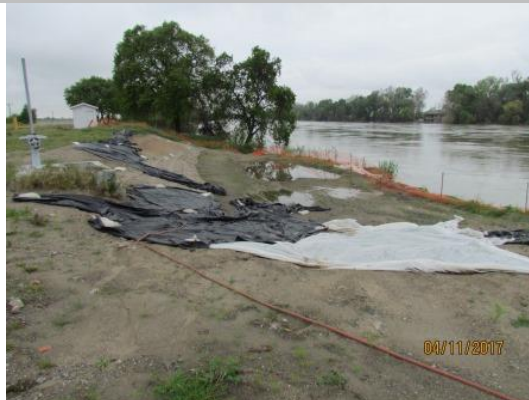
Photo 1 of 1 : SP_2017_RD1600_191_25_20170413_00123.jpg

LM Start	0.08	Rating **	M	Issue No.	25
LM End	0.08	Issue Type +	Ma	Location *	WS
Category	Earthen Levee		GPS Latitude/Longitude		
			Start	End	
Item	Erosion / Bank Caving		38.676163 °	38.676163 °	
			-121.631005 °	-121.631005 °	
DWR ID	DWR_RD1600_01_s_2017_25				
Comment Code					
E2 : Schedule repair of erosion site prior to the next inspection.					
Inspector Comment					
Visibile rills on the waterside levee slope. RD placed visqueen and sandbags to prevent further erosion.

Runoff erosion on waterside levee slope. LMA placed visqueen to prevent further erosion. Spring 2017.

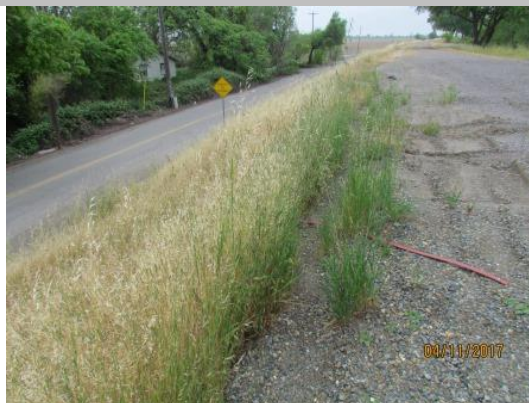
Photo 1 of 1 : SP_2017_RD1600_191_39_20170413_00124.jpg

Tall grass on landside levee slope, blocking visibility. Spring 2017.

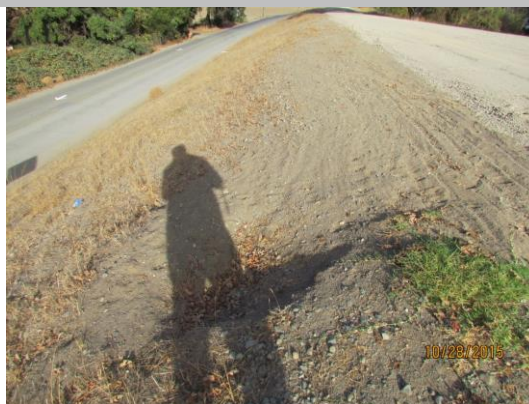
Photo 1 of 1 : SP_2017_RD1600_191_38_20170320_00043.jpg

LM Start	0.12	Rating **	A/W	Issue No.	38
LM End	0.12	Issue Type +	Ma	Location *	LS
Category	Earthen Levee			GPS Latitude/Longitude	
				Start	End
Item	Slope Stability			38.676654 °	38.676654 °
				-121.631348 °	-121.631348 °
DWR ID	DWR_RD1600_01_f_2015_38				
Comment Code					
S3 : Repair the levee slope damaged by vehicle traffic and prevent access where possible.					
Inspector Comment

View of a slope depression on the landward side of the levee looking downstream. Fall 2015.

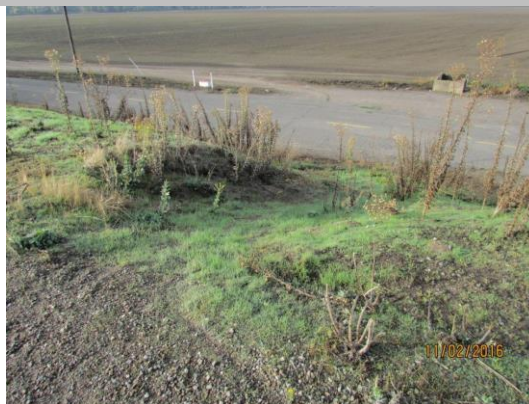
Photo 1 of 2 : SP_2017_RD1600_191_133_20170320_00082.jpg

LM Start	0.53	Rating **	M	Issue No.	133
LM End	0.53	Issue Type +	Ma	Location *	LS
Category	Earthen Levee			GPS Latitude/Longitude	
				Start	End
Item	Slope Stability			38.682140 °	38.682140 °
				-121.634083 °	-121.634083 °
DWR ID	DWR_RD1600_01_f_2013_133				
Comment Code					
S2 : Repair the levee slope damaged by foot traffic and prevent access where possible.					
Inspector Comment

Updated view of the slope stability site. Fall 2016.

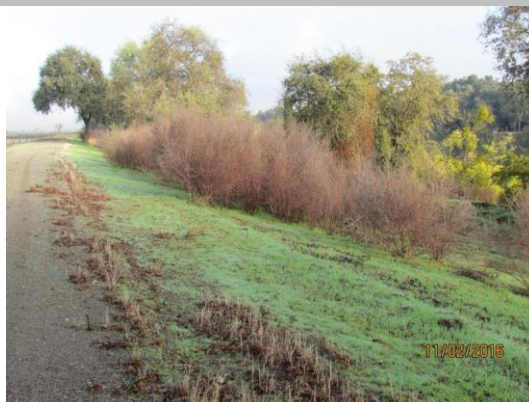
Photo 3 of 3 : SP_2017_RD1600_191_29_20170320_00035.jpg

LM Start	0.60	Rating **	M	Issue No.	29
LM End	0.62	Issue Type +	Ma	Location *	WS
Category	Earthen Levee			GPS Latitude/Longitude	
				Start	End
Item	Vegetation			38.683238 °	38.683415 °
				-121.634388 °	-121.634448 °
DWR ID	DWR_RD1600_01_s_2016_29				
Comment Code					
V2 : Remove the wild growth other than native grasses from the levee slopes.					
Inspector Comment					
Recommend removal of willow trees.

Updated view of willows on waterward side. Fall 2016.

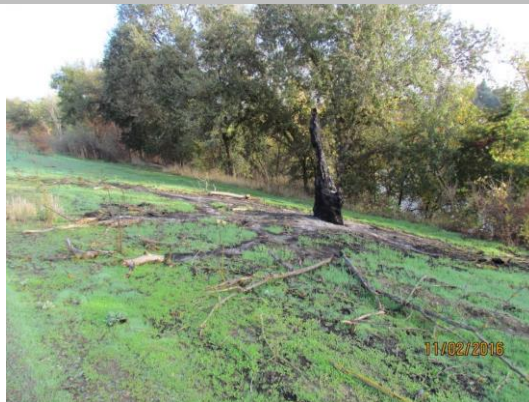
Photo 2 of 2 : SP_2017_RD1600_191_624_20170320_00089.jpg

Dying tree on waterward side was burnt. Fall 2016.

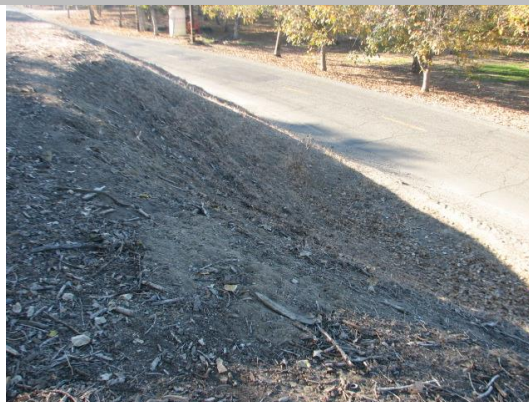
Photo 1 of 2 : SP_2017_RD1600_191_134_20170320_00084.jpg

LM Start	0.97	Rating **	M	Issue No.	134
LM End	0.97	Issue Type +	Ma	Location *	LS
Category	Earthen Levee			GPS Latitude/Longitude	
				Start	End
Item	Slope Stability			38.688454 °	38.688454 °
				-121.635528 °	-121.635528 °
DWR ID	DWR_RD1600_01_f_2013_134				
Comment Code					
S1 : Repair slope instability.					
Inspector Comment

The levee has a deep depression caused by removed tree. Fall 2013

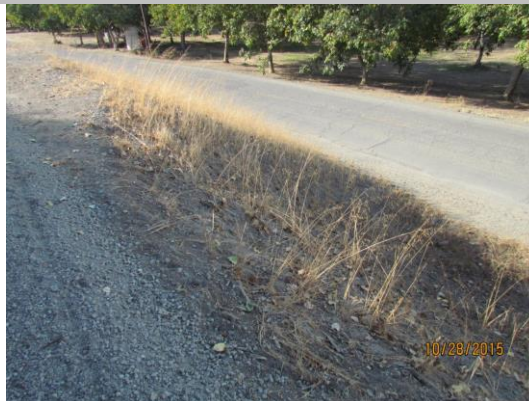
Photo 2 of 2 : SP_2017_RD1600_191_134_20170320_00085.jpg

LM Start	0.97	Rating **	M	Issue No.	134 (cont)	
LM End	0.97	Issue Type +	Ma	Location *	LS	
Category	Earthen Levee			GPS Latitude/Longitude		
				Start		End
Item	Slope Stability			38.688454 °		38.688454 °
				-121.635528 °		-121.635528 °
DWR ID	DWR_RD1600_01_f_2013_134					
Comment Code						
S1 : Repair slope instability.						
Inspector Comment

View of the depression of the slope on the landward side of the levee looking downstream. Fall 2015.

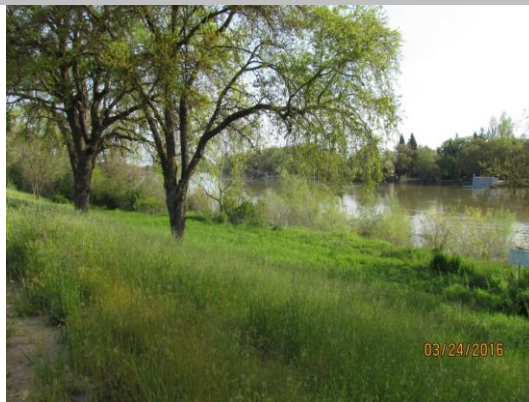
Photo 1 of 2 : SP_2017_RD1600_191_22_20170320_00024.jpg

View of the revegetation site at the berm edge on the waterward side of the levee looking upstream. Spring 2016.

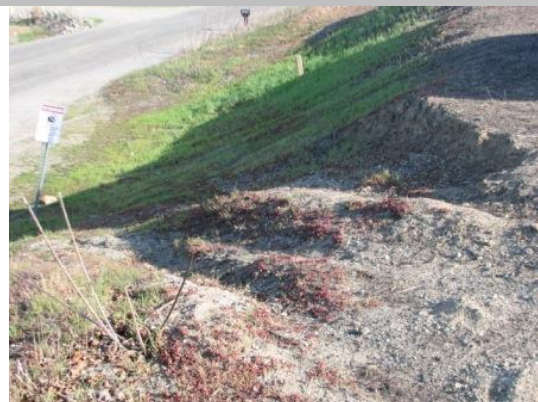
Photo 1 of 2 : SP_2017_RD1600_191_4_20170320_00007.jpg

LM Start	1.39	Rating **	M	Issue No.	4
LM End	1.39	Issue Type +	Ma	Location *	LS
Category	Earthen Levee			GPS Latitude/Longitude	
				Start	End
Item	Slope Stability			38.694395 °	38.694395 °
				-121.634376 °	-121.634376 °
DWR ID	DWR_RD1600_01_s_2017_4				
Comment Code					
S3 : Repair the levee slope damaged by vehicle traffic and prevent access where possible.					
Inspector Comment					
Damage looks like caused by vehicles.

Erosion from vehicles on levee slope. Spring 2013

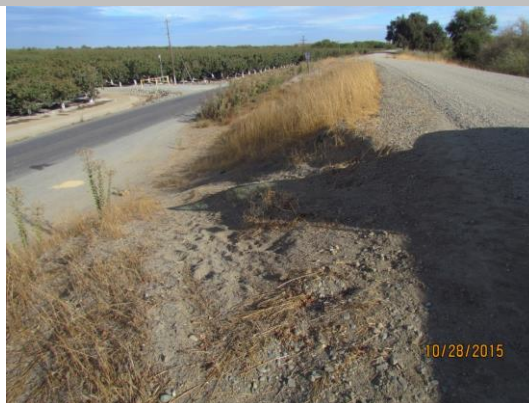
Photo 2 of 2 : SP_2017_RD1600_191_4_20170320_00008.jpg

LM Start	1.39	Rating **	M	Issue No.	4 (cont)	
LM End	1.39	Issue Type +	Ma	Location *	LS	
Category	Earthen Levee			GPS Latitude/Longitude		
				Start		End
Item	Slope Stability			38.694395 °		38.694395 °
				-121.634376 °		-121.634376 °
DWR ID	DWR_RD1600_01_s_2017_4					
Comment Code						
S3 : Repair the levee slope damaged by vehicle traffic and prevent access where possible.						
Inspector Comment						
Damage looks like caused by vehicles.

View of the slope stability caused by vehicles on the landward side of the levee looking upstream. Fall 2015.

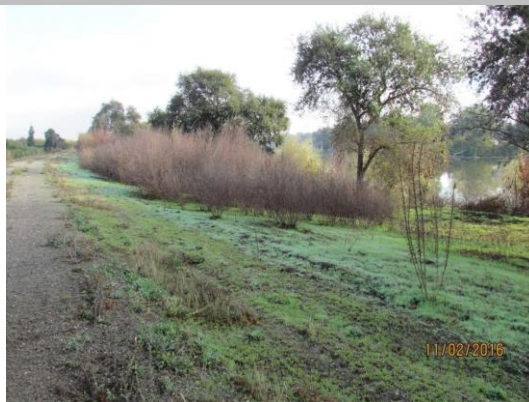
Photo 1 of 1 : SP_2017_RD1600_191_50_20170320_00054.jpg

View of willows on waterward side of the levee. Recommended removal. Fall 2016.

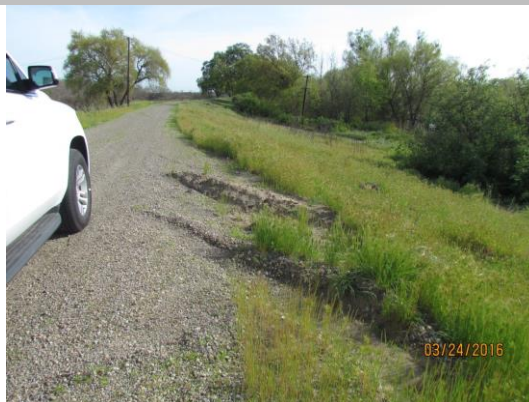
Photo 1 of 1 : SP_2017_RD1600_191_71_20170320_00073.jpg

LM Start	1.72	Rating **	M	Issue No.	71
LM End	1.72	Issue Type +	Ma	Location *	WS
Category	Earthen Levee			GPS Latitude/Longitude	
				Start	End
Item	Slope Stability			38.698628 °	38.698628 °
				-121.631694 °	-121.631694 °
DWR ID	DWR_RD1600_01_s_2016_71				
Comment Code					
S3 : Repair the levee slope damaged by vehicle traffic and prevent access where possible.					
Inspector Comment

View of the ruts on the shoulder of the levee on the waterward side.
Spring 2016.

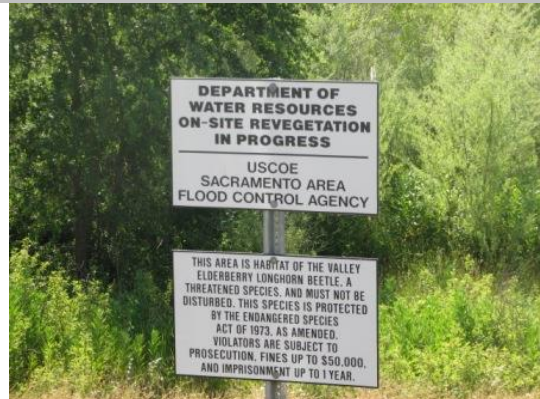
Photo 2 of 2 : SP_2017_RD1600_191_31_20170320_00039.jpg

Revegetation site with the Elderberry Beetle. Photo taken spring 2012.

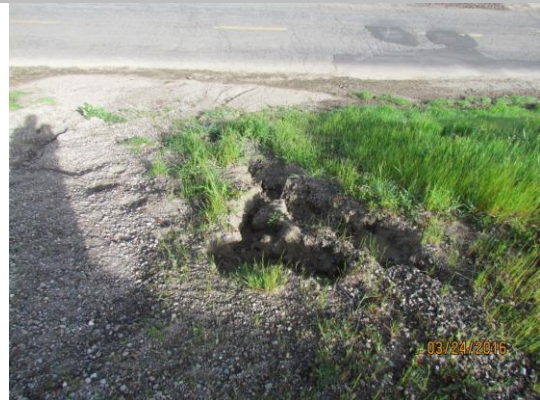
Photo 1 of 4 : SP_2017_RD1600_191_72_20170320_00074.jpg

LM Start	2.01	Rating **	M	Issue No.	72
LM End	2.01	Issue Type +	Ma	Location *	LS
Category	Earthen Levee			GPS Latitude/Longitude	
				Start	End
Item	Erosion / Bank Caving			38.701605 °	38.701605 °
				-121.627954 °	-121.627954 °
DWR ID	DWR_RD1600_01_s_2016_72				
Comment Code					
E2 : Schedule repair of erosion site prior to the next inspection.					
Inspector Comment					
Erosion seems to be caused by rain runoffs. Slope is graveled. Unsure if it is being used as a ramp.

Erosion is on the landward side of the levee about midway from the shoulder of the levee. Spring 2016.

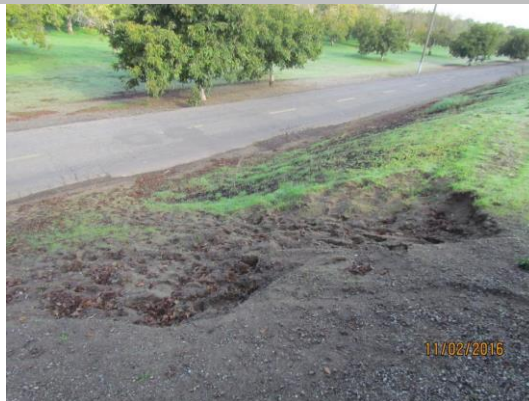
Photo 2 of 4 : SP_2017_RD1600_191_72_20170320_00075.jpg

LM Start	2.01	Rating **	M	Issue No.	72 (cont)	
LM End	2.01	Issue Type +	Ma	Location *	LS	
Category	Earthen Levee			GPS Latitude/Longitude		
				Start	End	
Item	Erosion / Bank Caving			38.701605 °	38.701605 °	
				-121.627954 °	-121.627954 °	
DWR ID	DWR_RD1600_01_s_2016_72					
Comment Code						
E2 : Schedule repair of erosion site prior to the next inspection.						
Inspector Comment						
Erosion seems to be caused by rain runoffs. Slope is graveled. Unsure if it is being used as a ramp.

Updated view of the erosion site. Fall 2016.

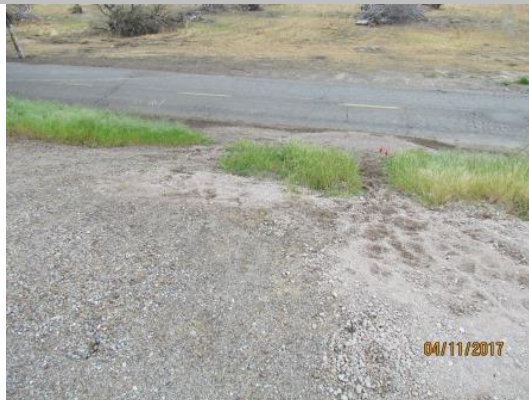
Photo 4 of 4 : SP_2017_RD1600_191_72_20170413_00126.jpg

Updated view of the erosion site. Spring 2017.

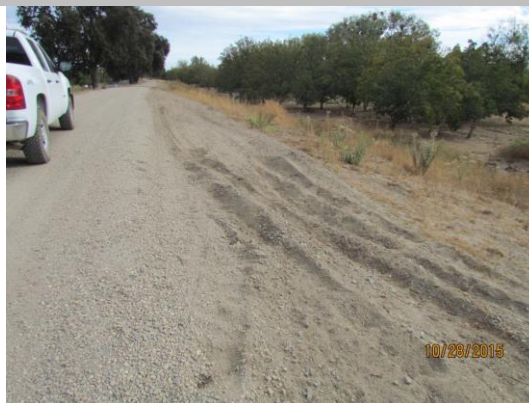
Photo 1 of 1 : SP_2017_RD1600_191_52_20170320_00056.jpg

LM Start	2.02	Rating **	M	Issue No.	52
LM End	2.02	Issue Type +	Ma	Location *	WS
Category	Earthen Levee			GPS Latitude/Longitude	
				Start	End
Item	Slope Stability			38.701753 °	38.701753 °
				-121.627734 °	-121.627734 °
DWR ID	DWR_RD1600_01_f_2015_52				
Comment Code					
S3 : Repair the levee slope damaged by vehicle traffic and prevent access where possible.					
Inspector Comment

View of the slope stability caused by vehicles on the waterward side of the levee looking upstream. Fall 2015.

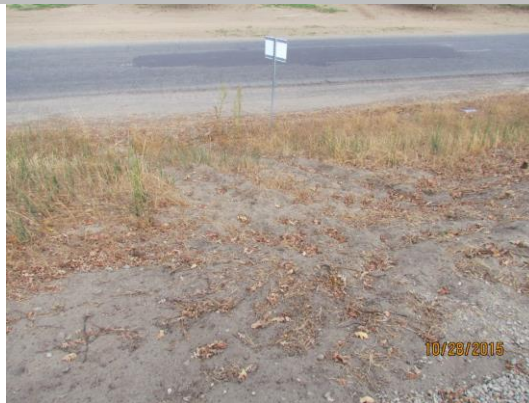
Photo 1 of 1 : SP_2017_RD1600_191_55_20170320_00059.jpg

LM Start	2.10	Rating **	M	Issue No.	55
LM End	2.10	Issue Type +	Ma	Location *	LS
Category	Earthen Levee			GPS Latitude/Longitude	
				Start	End
Item	Slope Stability			38.702416 °	38.702416 °
				-121.626593 °	-121.626593 °
DWR ID	DWR_RD1600_01_f_2015_55				
Comment Code					
S3 : Repair the levee slope damaged by vehicle traffic and prevent access where possible.					
Inspector Comment

View of the slope stability damaged by vehicles on the landward side of the levee. Fall 2015.

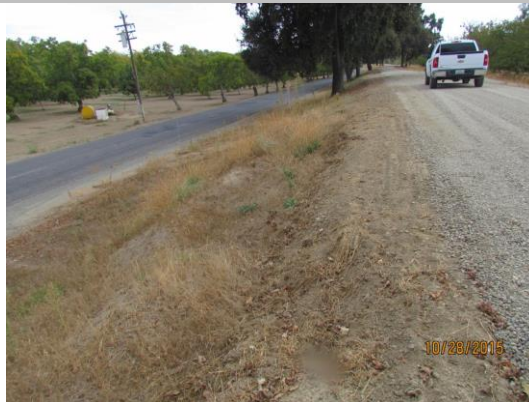
Photo 1 of 2 : SP_2017_RD1600_191_56_20170320_00060.jpg

LM Start	2.17	Rating **	M	Issue No.	56
LM End	2.17	Issue Type +	Ma	Location *	LS
Category	Earthen Levee			GPS Latitude/Longitude	
				Start	End
Item	Slope Stability			38.703025 °	38.703025 °
				-121.625605 °	-121.625605 °
DWR ID	DWR_RD1600_01_f_2015_56				
Comment Code					
S1 : Repair slope instability.					
Inspector Comment

View of the sloughing on the landward side of the levee looking upstream. Fall 2015.

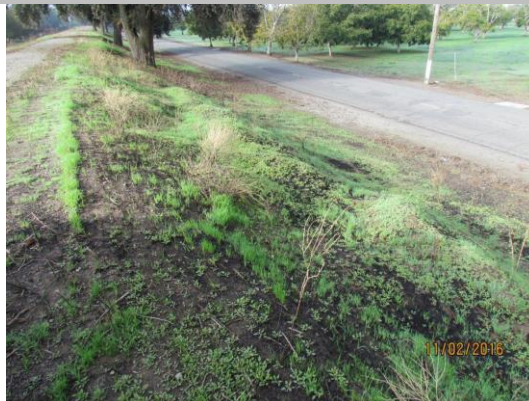
Photo 2 of 2 : SP_2017_RD1600_191_56_20170320_00061.jpg

LM Start	2.17	Rating **	M	Issue No.	56 (cont)	
LM End	2.17	Issue Type +	Ma	Location *	LS	
Category	Earthen Levee			GPS Latitude/Longitude		
				Start		End
Item	Slope Stability			38.703025 °		38.703025 °
				-121.625605 °		-121.625605 °
DWR ID	DWR_RD1600_01_f_2015_56					
Comment Code						
S1 : Repair slope instability.						
Inspector Comment

Updated view of the sloughing on LS slope. Fall 2016.

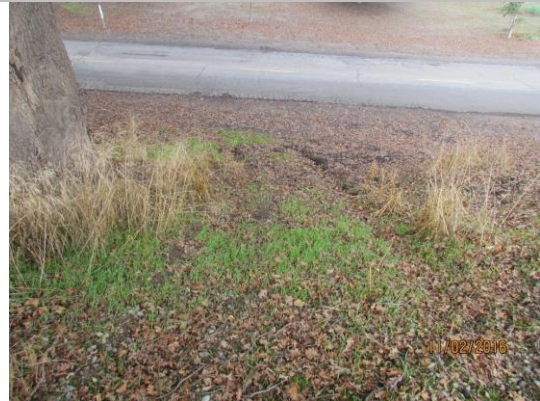
Photo 1 of 1 : SP_2017_RD1600_191_47_20170320_00050.jpg

LM Start	2.93	Rating **	M	Issue No.	47
LM End	2.93	Issue Type +	Ma	Location *	LS
Category	Earthen Levee			GPS Latitude/Longitude	
				Start	End
Item	Slope Stability			38.710518 °	38.710518 °
				-121.615366 °	-121.615366 °
DWR ID	DWR_RD1600_01_f_2016_47				
Comment Code					
S3 : Repair the levee slope damaged by vehicle traffic and prevent access where possible.					
Inspector Comment

LS levee slope damaged by a vehicle. Fall 2016.

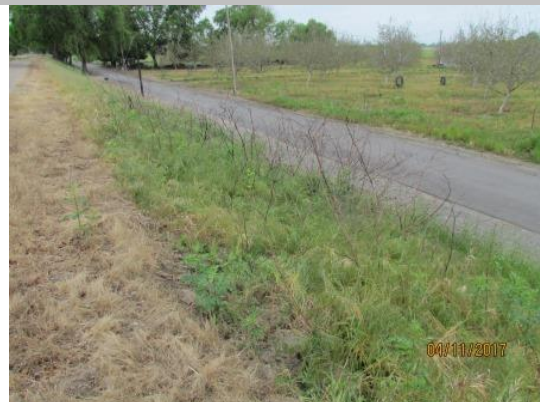
Photo 1 of 1 : SP_2017_RD1600_191_75_20170413_00127.jpg

Wild growth on landside levee slope. Spring 2017.

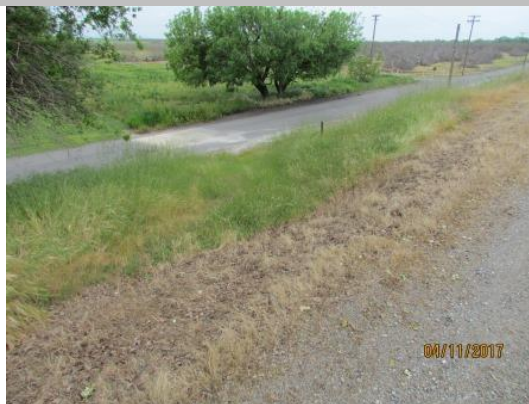
Photo 1 of 1 : SP_2017_RD1600_191_76_20170413_00128.jpg

Slope depression on landside levee slope from vehicle traffic. Spring 2017.

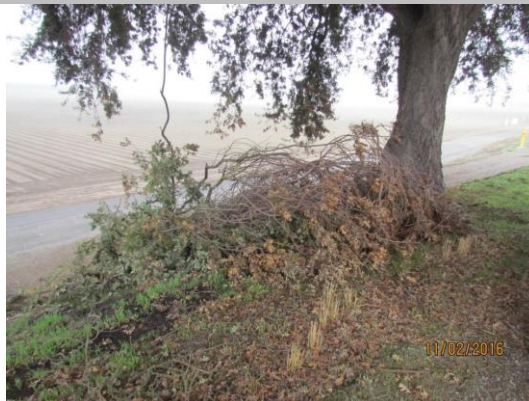
Photo 1 of 1 : SP_2017_RD1600_191_54_20170320_00058.jpg

Prunings on landside slope. Fall 2016.

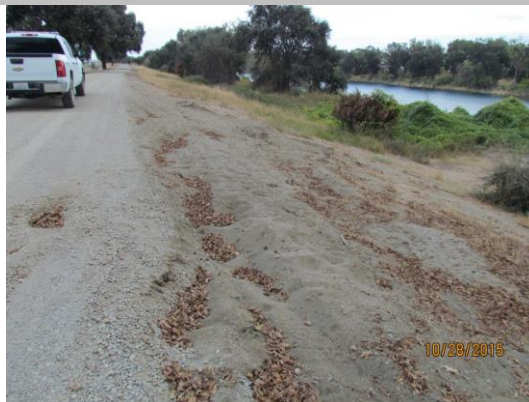
Photo 1 of 1 : SP_2017_RD1600_191_67_20170320_00070.jpg

View of the shoulder damaged by vehicles on the waterward side of the levee looking upstream. Fall 2015.

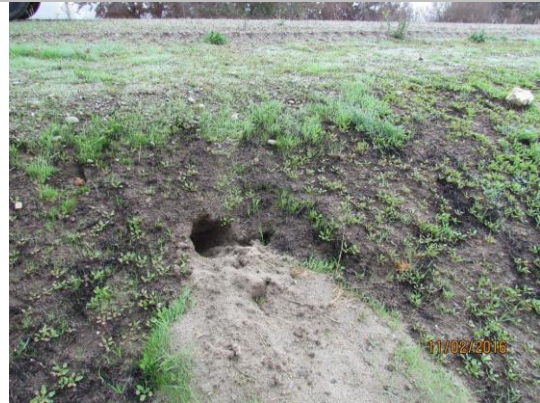
Photo 1 of 1 : SP_2017_RD1600_191_57_20170320_00062.jpg

Animal burrows on LS slope near the crown. Fall 2016.

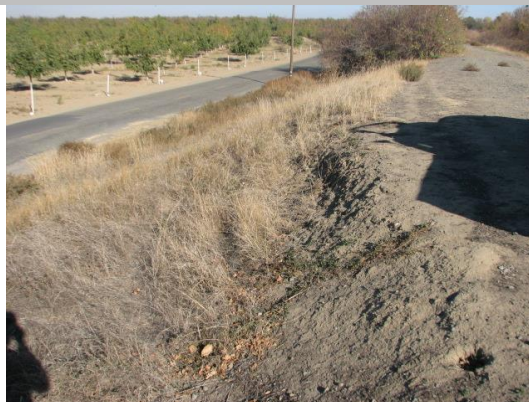
Photo 1 of 2 : SP_2017_RD1600_191_141_20170320_00086.jpg

The erosion at the shoulder of the levee could be slope instability. Fall 2013

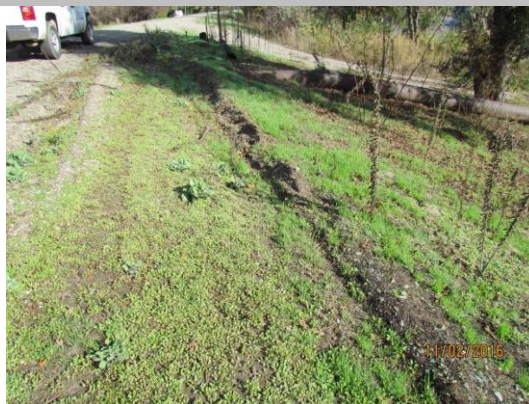
Photo 1 of 1 : SP_2017_RD1600_191_44_20170320_00048.jpg

View of WS slope depression. Fall 2016.

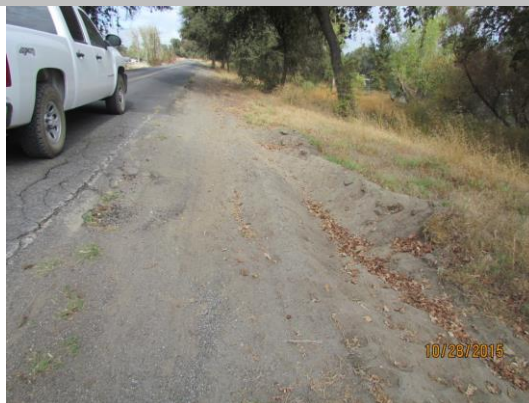
Photo 1 of 1 : SP_2017_RD1600_191_58_20170320_00063.jpg

View of the slope stability on the waterward side of the levee looking upstream. Fall 2015.

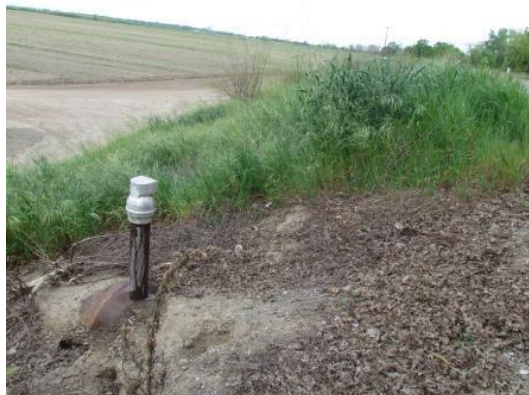
Photo 1 of 2 : SP_2017_RD1600_191_1199_20170320_00097.jpg

View of erosion and pipe on the landward side of the levee looking upstream. Spring 2015.

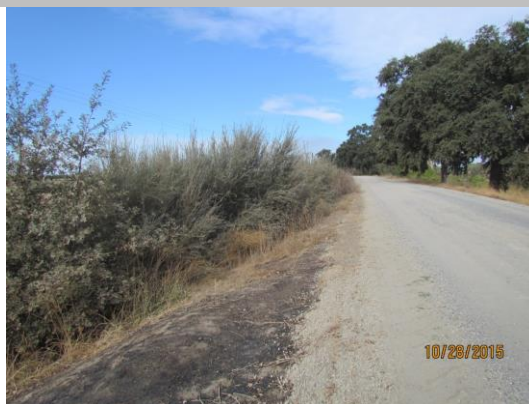
Photo 2 of 2 : SP_2017_RD1600_191_631_20170320_00096.jpg

View of the brush and vegetation on the landward side of the levee. Fall 2015.

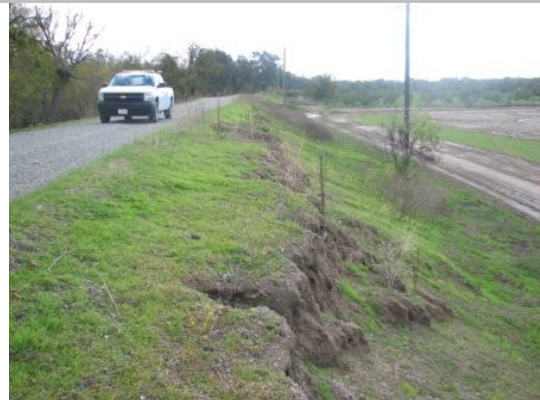
Photo 1 of 3 : SP_2017_RD1600_191_27_20170320_00028.jpg

The erosion appears to be moving closer to the shoulder.

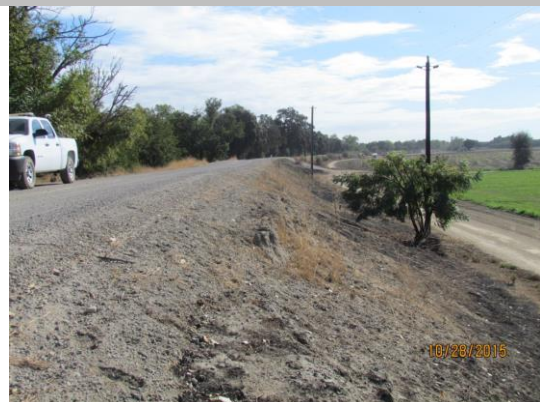
Photo 2 of 3 : SP_2017_RD1600_191_27_20170320_00029.jpg

The erosion seems to have been fixed. There still seems to be some erosion on the landward side of the levee looking downstream. Fall 2015.

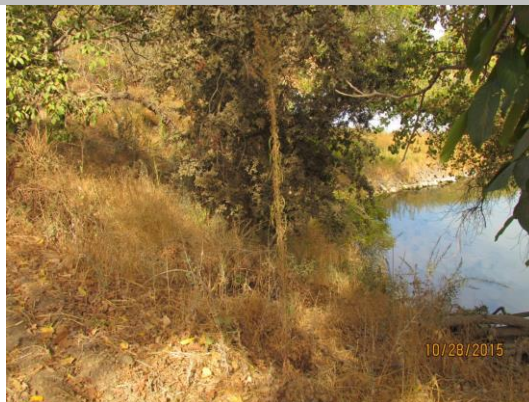
Photo 2 of 2 : SP_2017_RD1600_191_30_20170320_00037.jpg

View of the erosion into the berm area that needs to be monitored. Fall 2015.

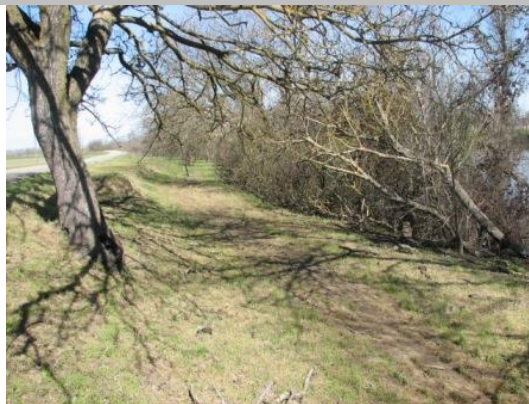
Photo 3 of 5 : SP_2017_RD1600_191_20_20170320_00018.jpg

The erosion is eroding away at the berm area.

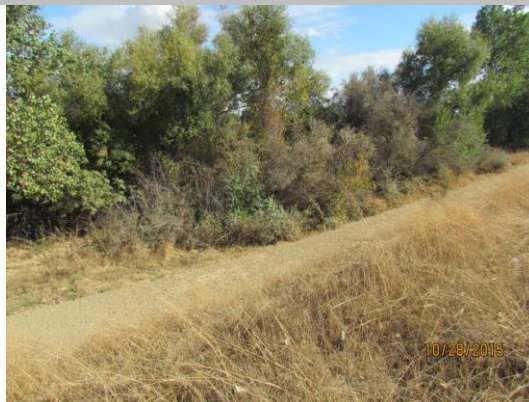
Photo 3 of 3 : SP_2017_RD1600_191_21_20170320_00023.jpg

View of the erosion along the waterward berm of the levee. Fall 2015.

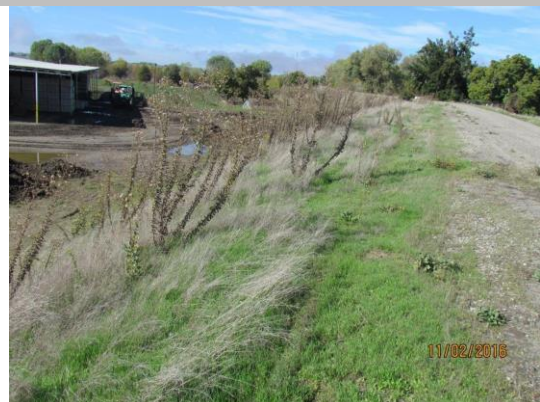
Photo 1 of 1 : SP_2017_RD1600_191_60_20170320_00065.jpg

Vegetation on LS slope partially blocks visibility. Fall 2016.

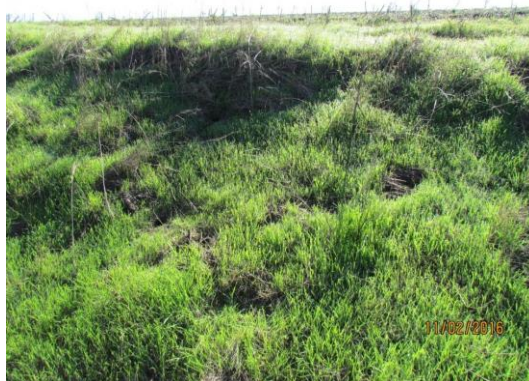
Photo 1 of 1 : SP_2017_RD1600_191_1200_20170320_00099.jpg

Rodent holes on waterside slope. Fall 2016.

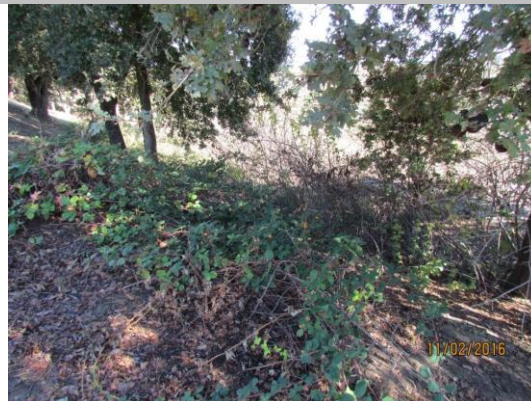
Photo 1 of 1 : SP_2017_RD1600_191_74_20170320_00079.jpg

Tree thinning on LS slope is needed. Fall 2016.

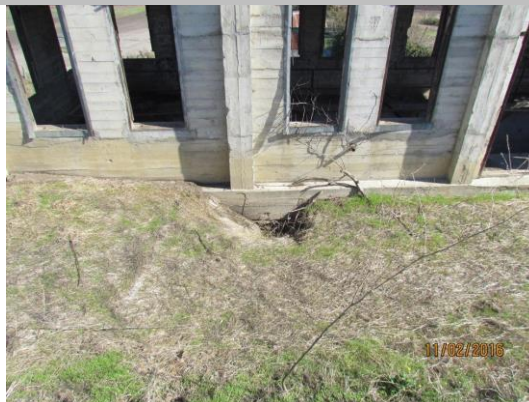
Photo 1 of 1 : SP_2017_RD1600_192_4_20170320_00003.jpg

Landside levee slope erosion at RD1600 pumping plant. Fall 2016.

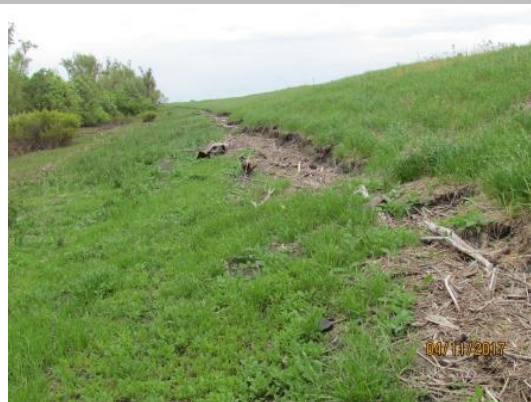
Photo 1 of 1 : SP_2017_RD1600_192_23_20170413_00032.jpg

View of wave wash damage on waterside levee slope. Spring 2017.

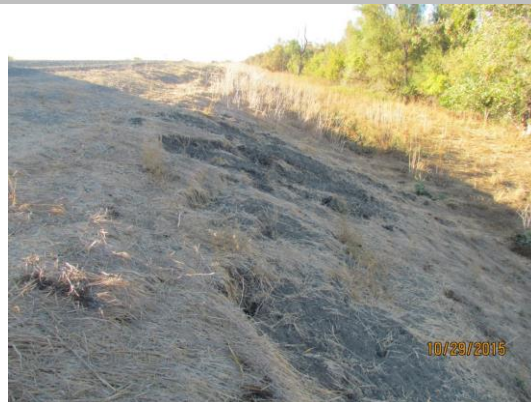
Photo 1 of 1 : SP_2017_RD1600_192_8_20170320_00008.jpg

View of the slope stability on the waterward side of the levee looking downstream. Fall 2015.

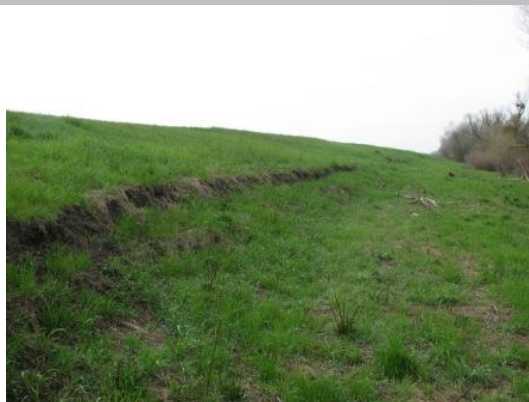
Photo 1 of 4 : SP_2017_RD1600_192_14_20170320_00012.jpg

A closer view of the wave wash damage along the bypass.

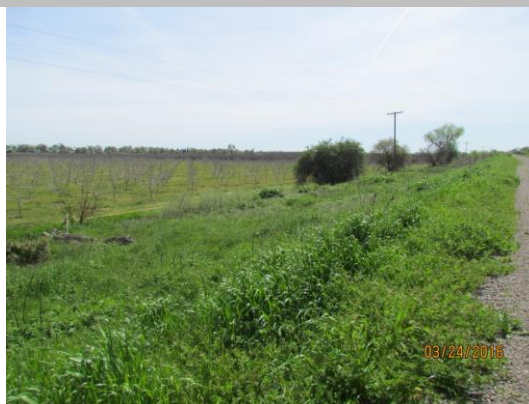
Photo 2 of 2 : SP_2017_RD1600_192_2_20170320_00002.jpg

View of the fallen tree on the landward side of the levee looking downstream. Spring 2016.

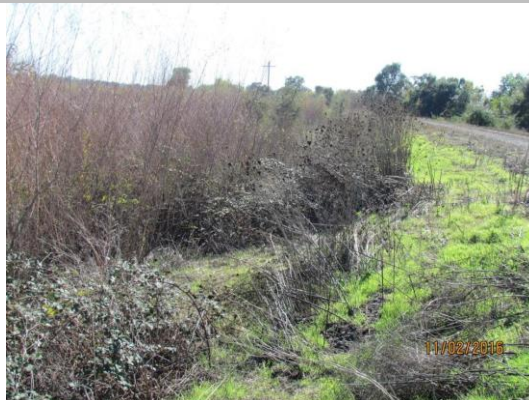
Photo 1 of 1 : SP_2017_RD1600_192_10_20170320_00009.jpg

View of vegetation on landside slope. Only about 20 ft. from the crown has been cleared. Fall 2016.

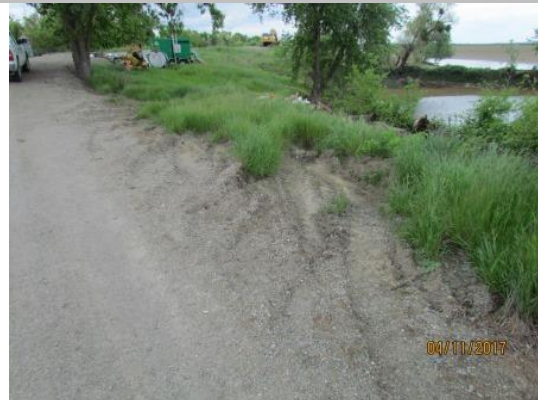
Photo 1 of 1 : SP_2017_RD1600_192_18_20170413_00025.jpg

Vehicle tracks on landside levee slope. Spring 2017.
